RAILWAY INVESTIGATION REPORT

R03T0080

DERAILMENT/COLLISION

Canadian Pacific Railway
Train No. 410–16
Mile 80.5, Belleville Subdivision
Melrose, Ontario
21 February 2003

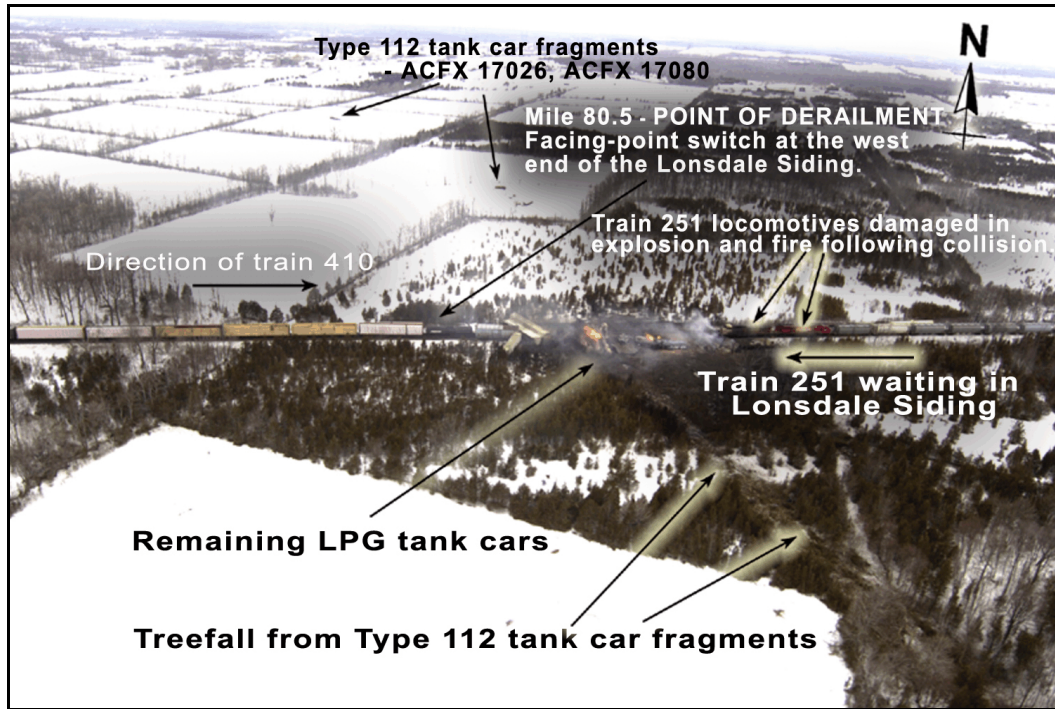
At approximately 0540, a wheel set on the 27th car of train 410 derailed to the south side of the main track at Mile 80.9. The derailed car continued eastward towards the switch point at Mile 80.5, where it took the diverging route into the Lonsdale Siding. The 27th car (SOO 18748, a loaded box car of lentils) then struck the side of the first locomotive (CP 8654) on train 251. The following two cars from train 410, the 28th and 29th cars, which were loaded with agricultural products, ran in behind and derailed to the north side of the track. The next seven cars of train 410, the 30th to 36th cars, were tank cars loaded with liquefied petroleum gas (LPG). The first loaded tank car derailed and struck the right front corner of the first locomotive of train 251 and exploded on impact. The second tank car also derailed and then exploded after heavy impact damage. This sequence was followed by explosions of the third and fifth LPG tank cars within 15 minutes of sustaining severe damage from derailed cars piling in from behind. Shortly after, the remaining three loaded LPG tank cars ruptured as a result of impact damage, failed safety appliances, and intense heat from the fire. The contents of the seven LPG tank cars were consumed in the fire (see Photo 1).

Photo 1. Aerial view of accident site on the day of occurrence (Source: Ontario Provincial Police)

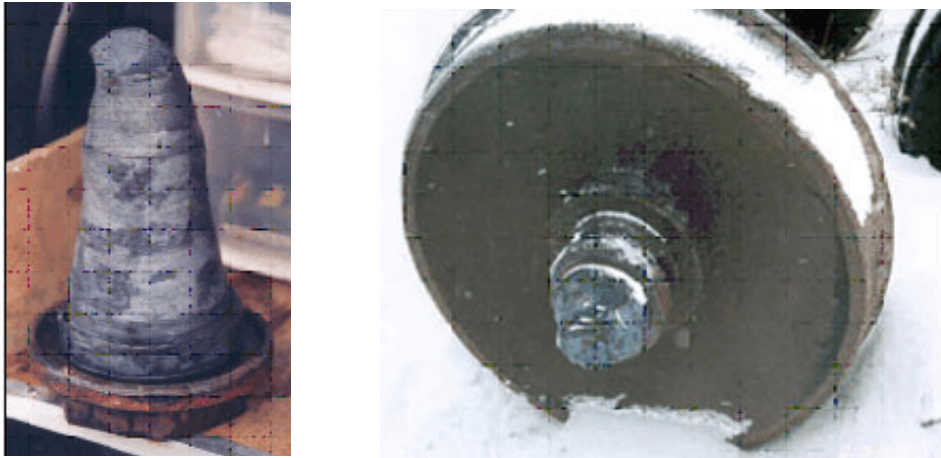
The wheels, axle, and recovered components from the burnt-off journal on axle 122 of the 27th car (see Photo 2) were sent to the TSB Engineering Laboratory for analysis. Both wheels were CJ33 type and had been manufactured in February 1985. No significant grease spatter was observed on either wheel plate. The wheel set “back to back” measurement was within specified limits. There were no significant shelling defects or other tread defects on either wheel.

The bearings were Class E BRENCO 6X11. The burnt-off bearing had experienced significant heat damage, and the outer seal and ring were missing. No grease remnants remained. The cause of the bearing failure could not be determined due to extensive heat damage, which changed the material microstructure and hardness.

Photo 2. Burnt-off journal and wheel assembly from car SOO 18748

An examination of the derailed rolling stock determined that a burnt-off journal at the No. 2 wheel on the 27th car (SOO 18748) of train 410 had occurred. Just prior to the derailment, the roller bearing overheated and seized. The axle then extruded, resulting in a reduction in cross-sectional thickness. After sufficient thinning, the overheated axle could no longer support the weight of the car, leading to a complete axle fracture.

The cause of the overheated bearing could not be determined due to the extensive damage to the axle journal and roller bearing. An examination of car SOO 18748 after the accident determined that there was grease spatter on the floor underframe, immediately above the failed roller bearing location. However, it could not be determined whether the grease spatter resulted from this overheated condition or was residue from a previously failed bearing, as there is no requirement to remove grease from the undercarriage of a car body from previously failed bearings.

Subsequent to this occurrence, CPR modified the software on all wayside detectors such that, while passing the detector, the alarm tone is immediately followed by a radio announcement identifying the nature of the defect (e.g. dragging equipment, hot box or hot wheel).
